RE: Wetland Impact Review
27 Beecher Road
Woodbridge, CT

**Environmental Review
27 Beecher Road - Woodbridge
Proposed Development
January 14, 2026**

PHOTOGRAPHS

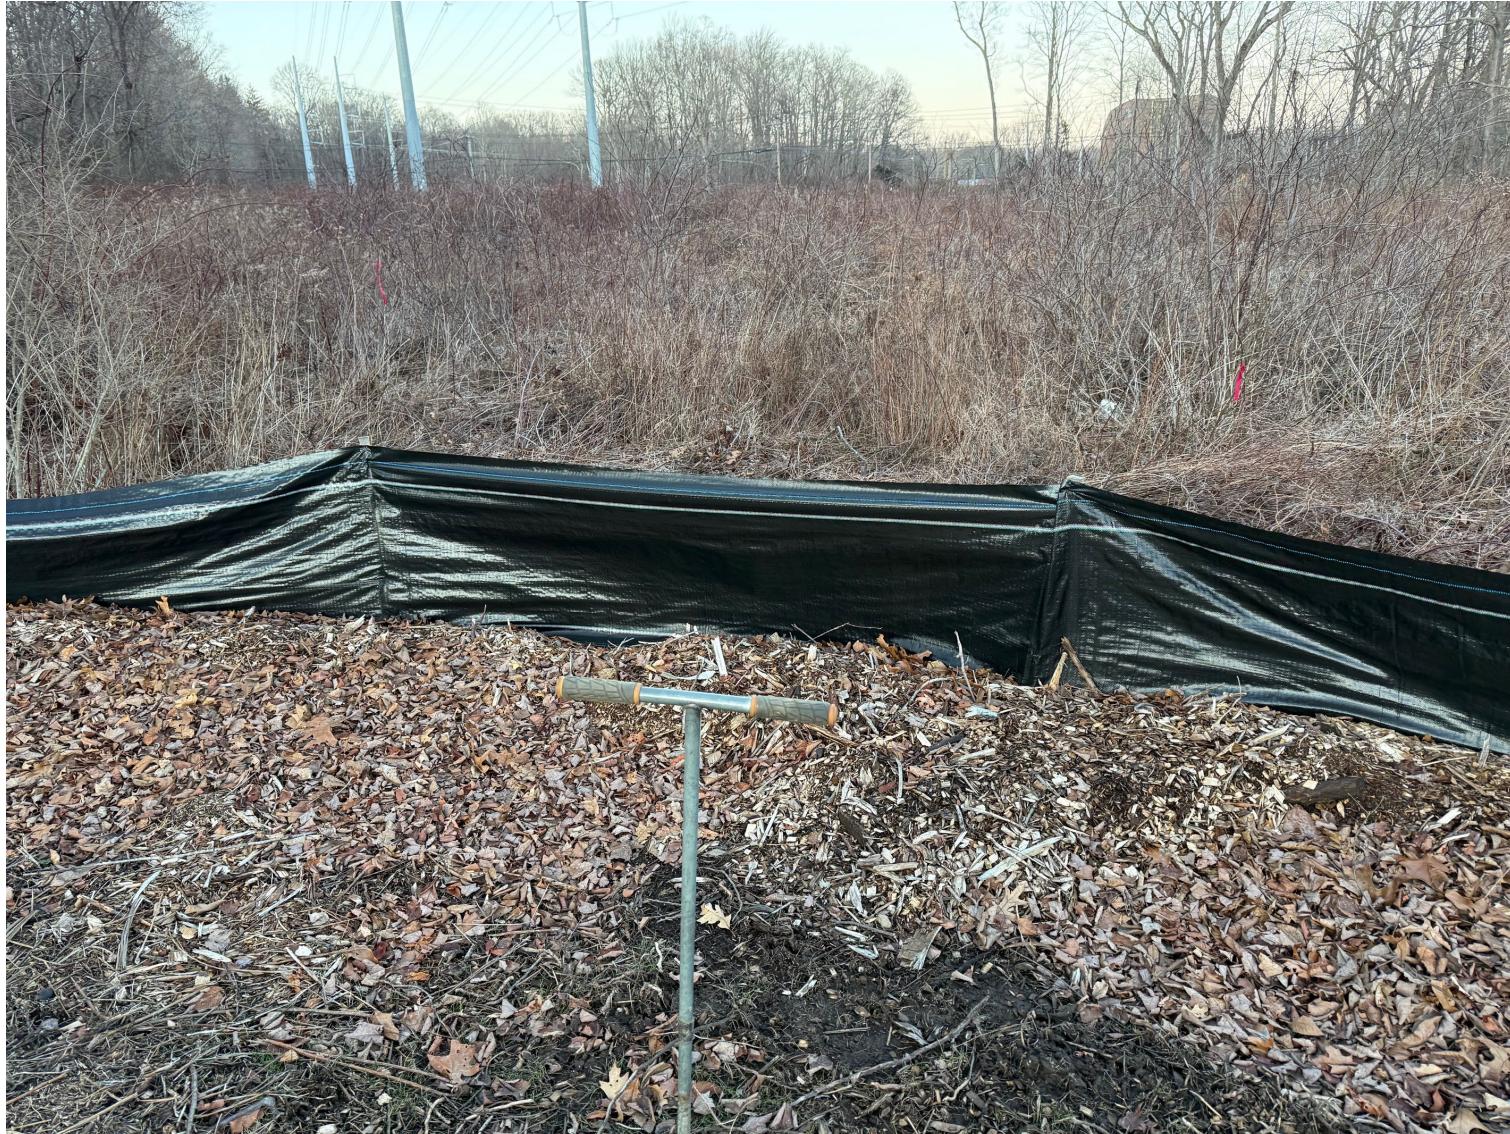
- MBI observed several red flags along the delineated wetland line. All of the flags indicated on the plan were not observed in the field and flag numbers were largely illegible. Using a hand auger and keying off of flags that were present, MBI conducted a series of borings upgradient of the wetland line. In the area of apparent Wetland Flag #20, we noted that topography was very flat, with no changes in microtopography that typically (but not always) provide visual clues for changes in soil type. Approximately 15 feet upgradient of the flag, we encountered a gleyed B horizon with 15-25% high chroma mottles. (see photos) These observations are consistent with poorly drained soils. As such, it is our opinion that the wetland flag is too low in the landscape and the line should be moved further west. Similarly, in the northeast area of the proposed development, upgradient of the installed silt fence and approximately 15-20 feet upgradient of apparent Wetland Flags #'s 4 and 5, we encountered similar soil conditions, consistent with poorly drained soils. As such, it is our opinion that the wetland flag is too low in the landscape and the line should be moved further southwest. The wetland test point completed by MBI in this area was upgradient of the silt fence suggesting that a portion of the wetland has been cleared in this area. (See Photos). MBI suggests that the flag locations should be remarked in the field using survey and that the line be reevaluated by the project Soil Scientist. MBI did not evaluate the entire wetland line.

Hand Auger at boring location in northeast portion of development site, upgradient of silt fence and apparent Wetland Flags 4 and 5.

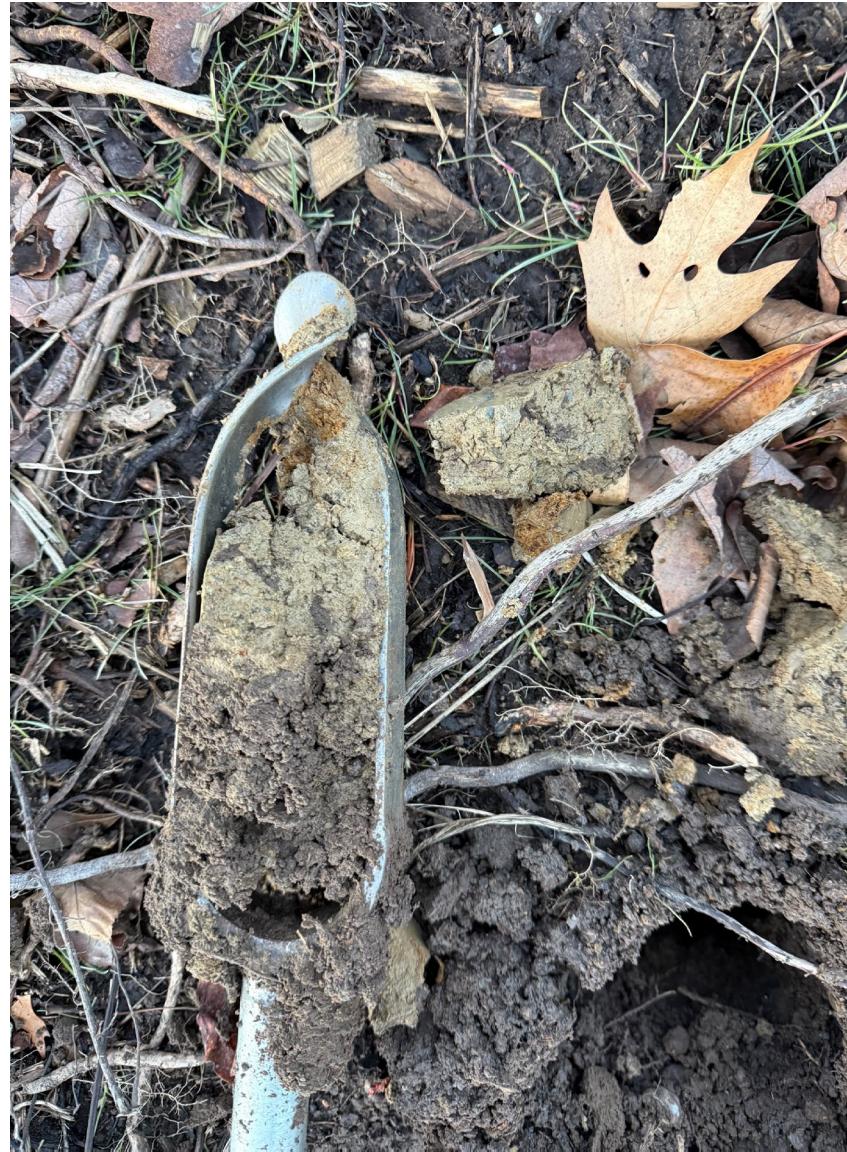
Soil observations at hand augered location. Apparent poorly-drained/wetland soils

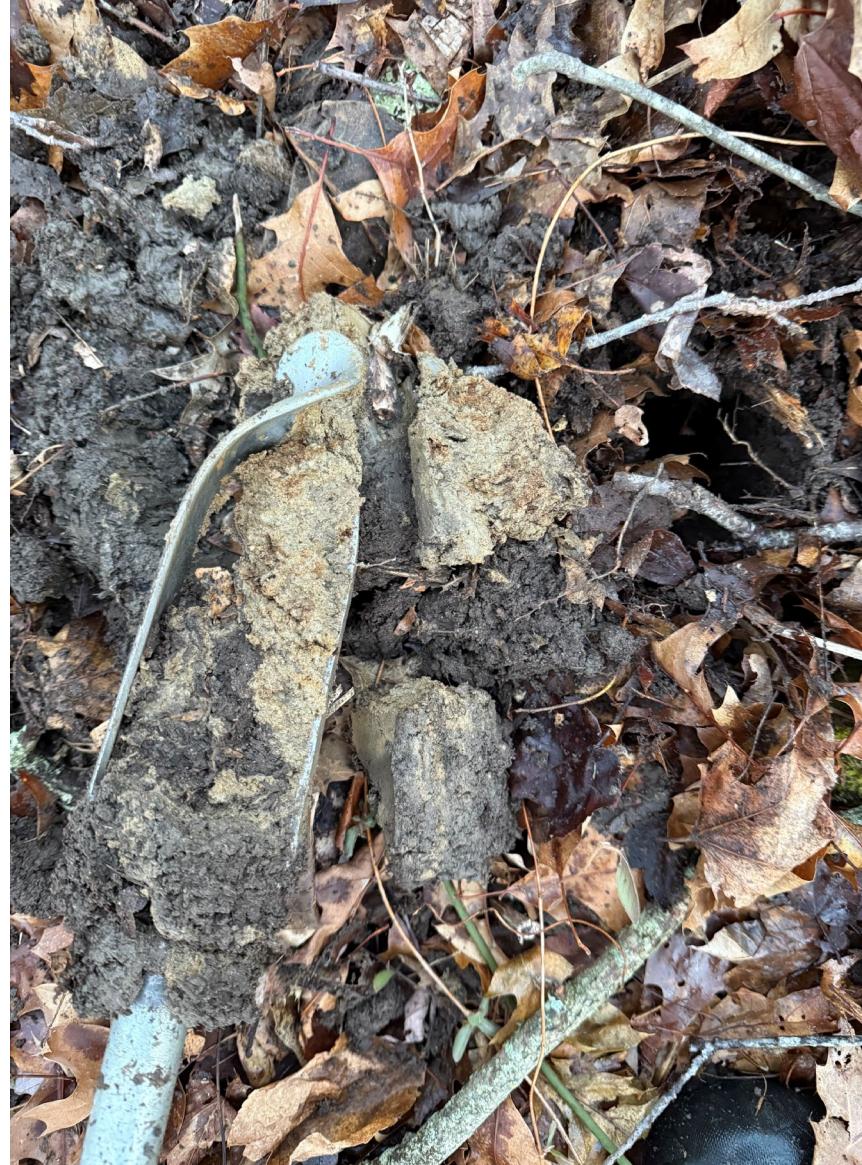
Soil observations at hand augered location above apparent Wetland Flag
20. Apparent poorly-drained/wetland soils
