SOUTHWEST CONSERVATION DISTRICT

Potential Ecological Restoration Projects for the old Woodbridge Country Club

50 Woodfield Road
Woodbridge, CT

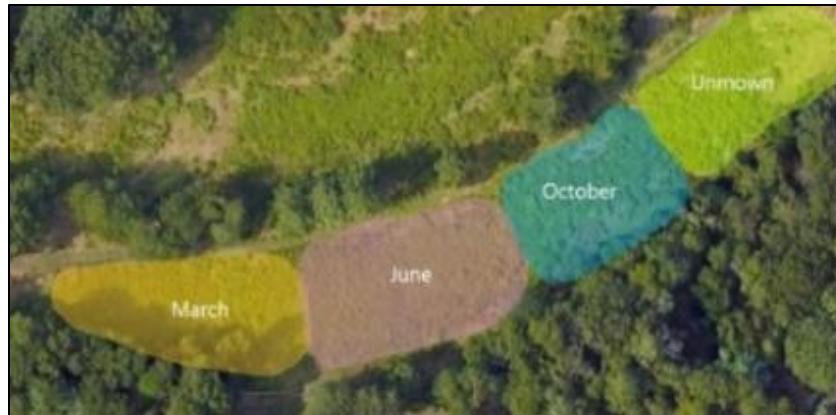
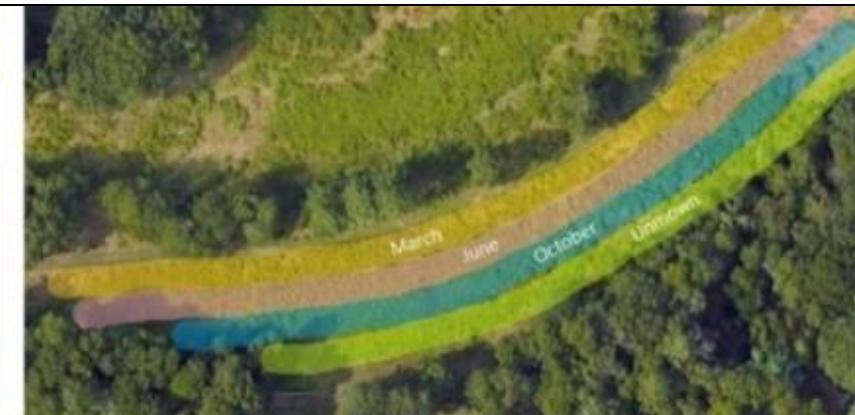
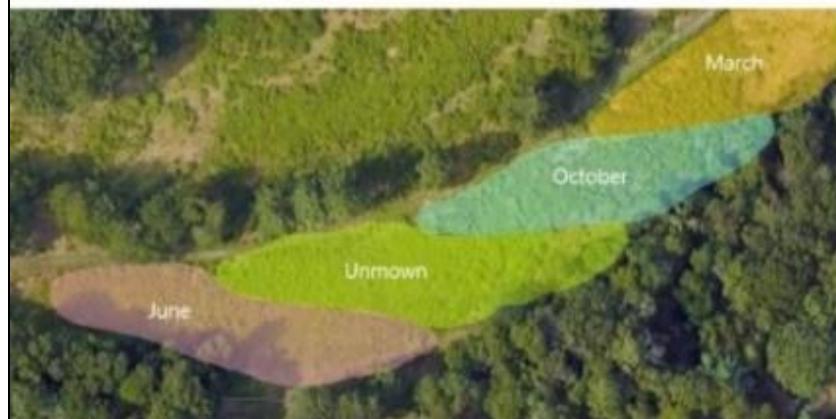
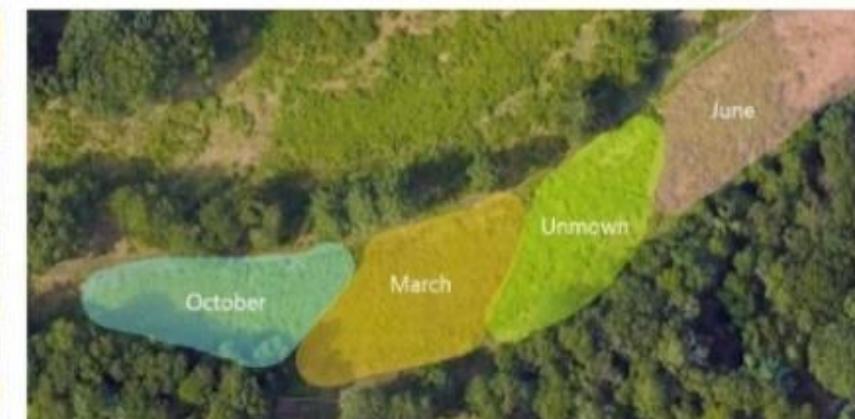
Figure 1. Example four-year rotational mowing plan.

First, simply [manage as a meadow](#). Rotationally mow the meadow at a height of 6-8 inches. Rotational mowing is the practice of mowing different sections of the meadow at different times a year rather than one complete annual cut. For example, cut $\frac{1}{4}$ of the meadow in March, $\frac{1}{4}$ in late June, and $\frac{1}{4}$ in October, and the remaining $\frac{1}{4}$ uncut for the year. The following year, repeat but in a different pattern. See an example 4-year rotation management plan in [Figure 1](#).

Using rotational mowing allows for managing invasives and woody species while leaving sections of habitat for a variety of pollinators and wildlife. The variation of mowing will allow light to access the soil at different times of the year in different areas for seed germination. It appears that the property is regenerating on its own. Native seed banks can last a long time, and more natives may appear over time under the new management regime.

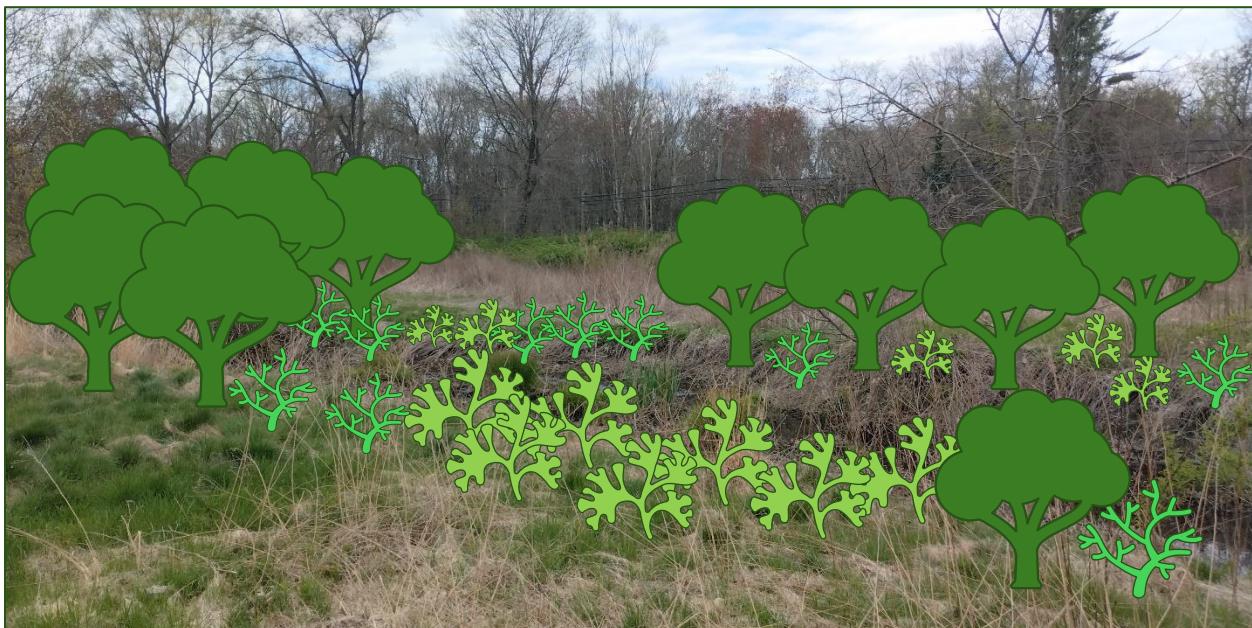
Figure 2. Conceptual example of using plant species with varying mature heights to protect the stream and build habitat while still allowing views to stream and beyond.

Once the invasive species are under control, native shrubs and/or forbs should be added to increase the riparian buffer and prevent further erosion around the stream. Selecting a mixture of native plant species with varying mature heights can ensure some views of the stream from the trail while maintaining a robust riparian buffer for stream health (**Figure 2**). Continued monitoring for invasives should continue to ensure they do not return or that invasives from the seed bank do not germinate.

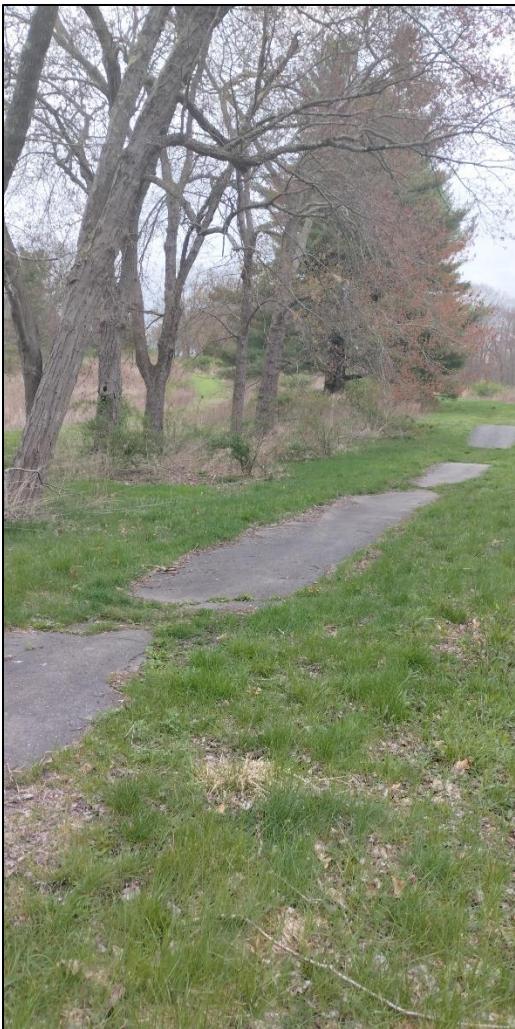
Photo 1. Pollinator Pathway – understory enhancement. North side of southern trail segment. Mix of deciduous & evergreen trees.

Understory Enhancement - For the strip of trees north of the trail segment, we recommend brush hogging stands of multiflora rose monthly from April to October and/or removing individual plants with a weed wrench or mattock. Mow and/or selectively smother areas of mugwort. Avoid all of these methods in the low/wet spots (potentially wetland soil/vernal pools). If any invasive species are present in these areas, use hand loppers to cut to just above ground level monthly. The continuous cutting will deplete the plant's resources over time.

Expect that invasive control will likely take 2-4 years. Once invasive plant species have been removed, we recommend enhancing the understory of the trees with a variety of native understory trees, shrubs and herbaceous forbs. Continued monitoring for invasives should continue to ensure they do not return or that invasives from the seed bank do not germinate. New native plantings can occur prior to complete invasive removal, because the new plants can help in decreasing invasive seed germination. However, diligent monitoring is necessary to ensure the invasives in the area remain under control.

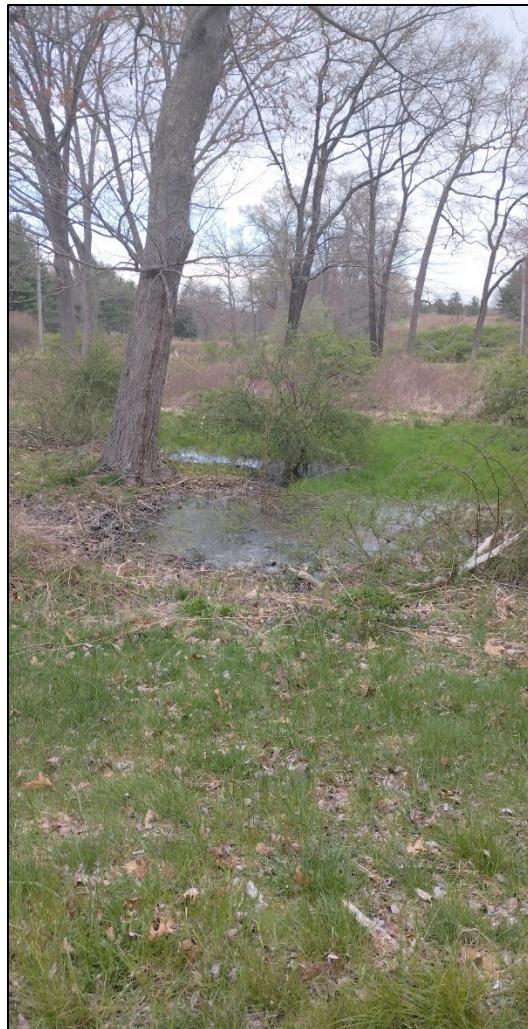
Understory Enhancement - There are several low/wet spots just north of the trail within the strip of trees, which includes red maples (*Acer rubrum*), white pine (*Pinus strobus*), and hickory (*Carya sp.*) (**Photo 2**). The understory of the trees is primarily grass, including native little bluestem (*Schizachyrium scoparium*) (**Photo 7 & 8**). There is no shrub understory except for invasive multiflora rose (*Rosa multiflora*).

Photo 2. Pollinator Pathway – understory enhancement. Low/wet spot on the north side of southern trail segment.

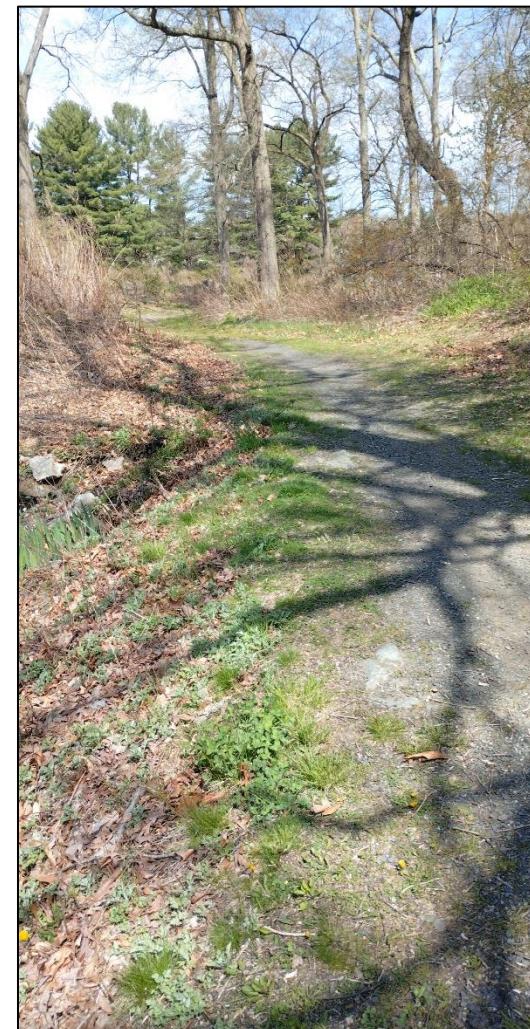
Photo 6. *Pond Restoration – understory enhancement.* Looking northward from the eastern trail segment at pond's edge.

Pond Edge Restoration - From the edge of the pond to 50 feet out, we recommend using hand loppers to cut invasive species to just above ground level, to avoid disturbing wetland and watercourse soils. Any work in this area will require a plan to be reviewed by [Woodbridge's IWWC](#) prior to any invasive species removal. Invasive removal will help restore and enhance the habitat adjacent to the small stream on site and prevent the spread of the invasives along the watercourse.

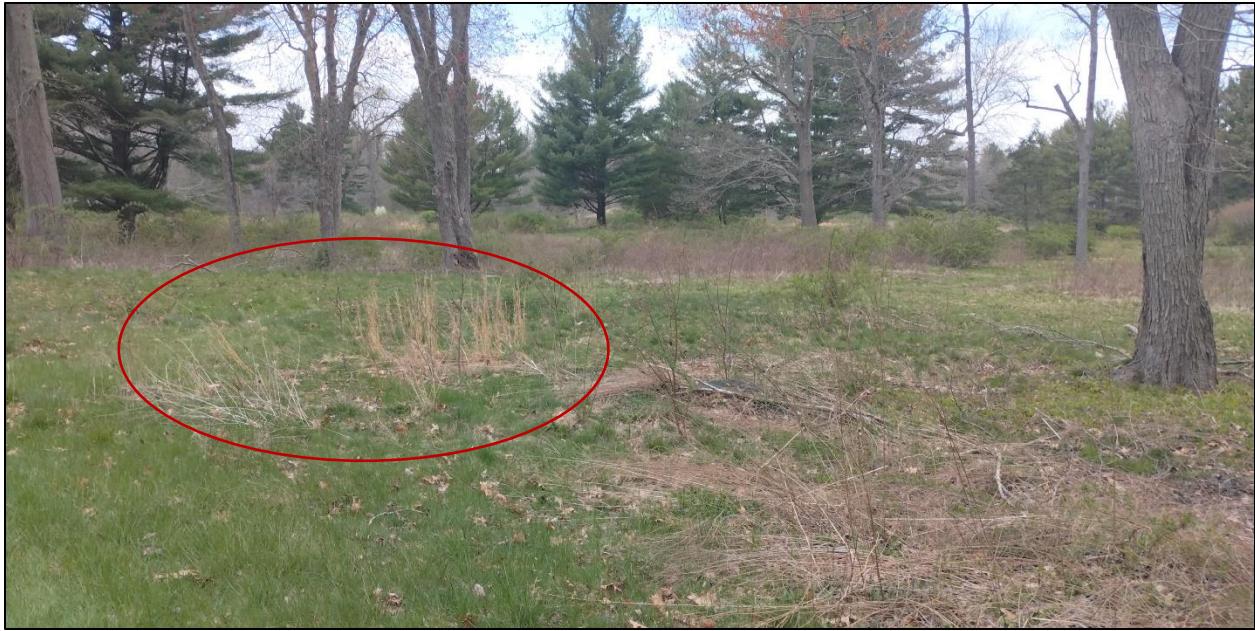
Photo 7. Pollinator Pathway –understory enhancement. North side of southern trail segment. Mix of deciduous & evergreen trees. Note evidence of existing little bluestem population (circled in red) and some invasive plant species.

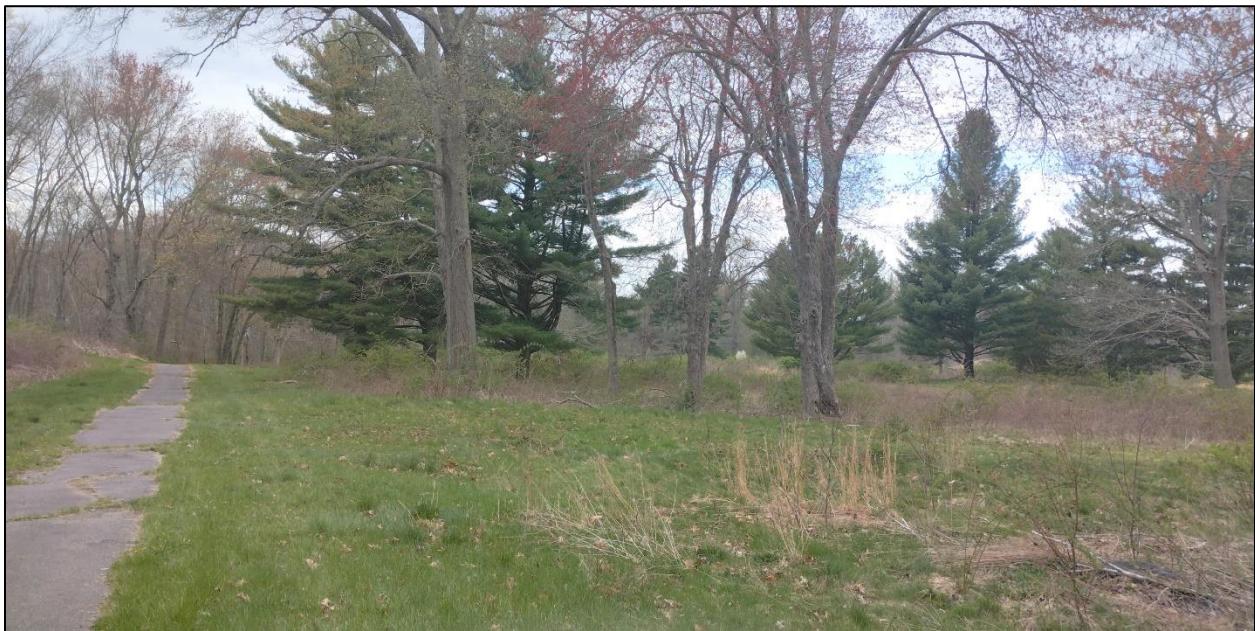
Photo 8. Pollinator Pathway –understory enhancement. North side of southern trail segment, right before trail turns northwesterly. Mix of deciduous & evergreen trees. Note evidence of existing little bluestem population and some invasive plant species.

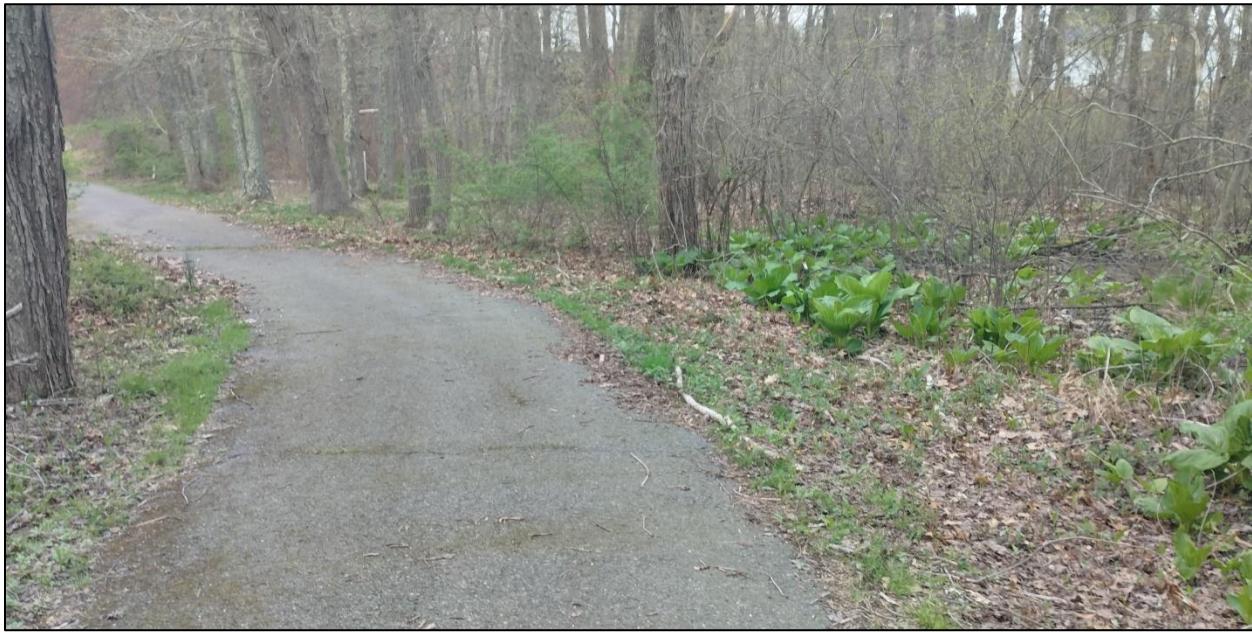
The forested wetland had a more diverse understory including skunk cabbage (*Symplocarpus foetidus*) and tussock sedge (*Carex stricta*). Native wood anemone (*Anemone quinquefolia*) and invasive multiflora rose (*Rosa multiflora*) were also found on the wetland edge next to the trail. This area as well as some of the area northwest of it are classified as Connecticut Wetlands (**Attachment B & E**).

Photo 9. *Pollinator Pathway –forested wetland.* South view from southern trail segment, right after trail turns northwesterly. A small, forested wetland with diverse species is adjacent to the existing trail.

For the edge of the forested wetland, we recommend using hand loppers to cut multiflora rose to just above ground level, to avoid disturbing wetland soils. Any work in this area will require a plan to be reviewed by [Woodbridge's IWWC](#) prior to any invasive species removal. Invasive removal will help restore and enhance the habitat adjacent to the wetland on site and prevent the spread of the invasives into the wetland.

Once the invasive species are under control, some native shrubs may be added to increase the buffer between the trail and the wetland. Continued monitoring for invasives should continue to ensure they do not return or that invasives from the seed bank do not germinate. Appropriate shrub species include spicebush (*Lindera benzoin*), highbush blueberry (*Vaccinium corymbosum*), swamp azalea (*Rhododendron viscosum*), sweet pepperbush (*Clethra alnifolia*), possum haw (*Viburnum nudum*), and winterberry (*Ilex verticillata*).

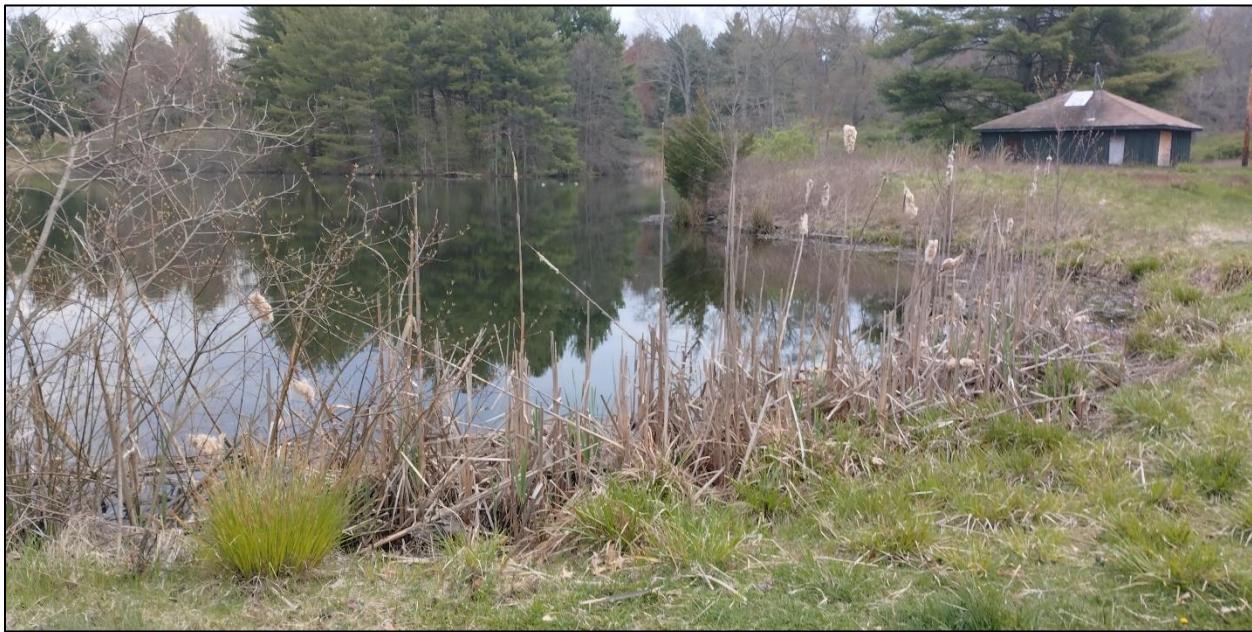
Photo 10. *Pond between Pollinator Pathway area and Riparian Restoration area.* Looking northeast after the western trail segment begins. Pond offers scenic view and additional habitat.

The western trail segment starts next to a large pond in the southwest corner of the property (**Photo 10 & 11**). Heading northerly, a small stream runs southward on the western side of the trail. It is largely lacking riparian buffer and shows sign of erosion (**Photo 12 & 13**). The existing buffer includes invasive species multiflora rose (*Rosa multiflora*) and mugwort (*Artemisia vulgaris*). Some reaches of the stream do have some riparian buffer (**Photo 14**), which could be further enhanced. More northerly, the small stream is within a wooded area (**Photo 15**). On both sides of the trail and the stream are patches of meadow and mixed stands of trees. This area is a mixture of Moist Dense Till Uplands and Well Drained Till Uplands (**Attachment D**). The depth of the water table is estimated between 46->200 cm or 18-> 78 inches (**Attachment C**). This section lies within the Wepawaug River watershed (**Attachment F**).

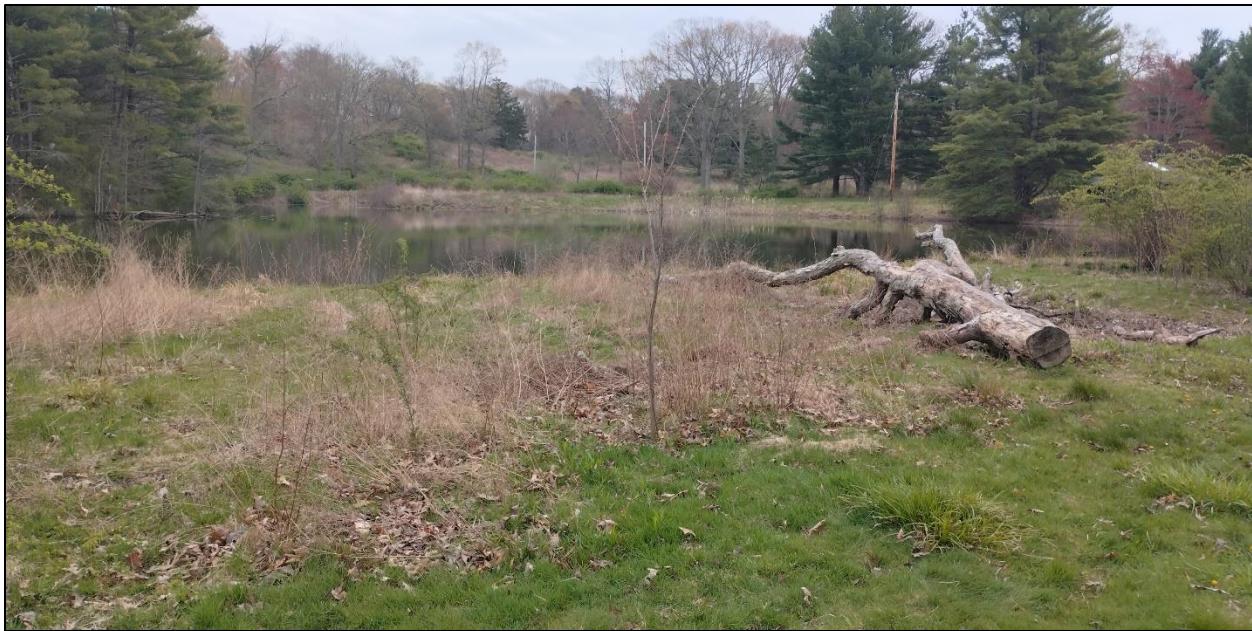
Photo 11. *Riparian Restoration –meadow enhancement.* Looking southward back at pond (Photo 10) from the western trail segment.

Invasive Removal in Surrounding Area- For meadow areas along the trail, we recommend brush hogging stands of multiflora rose monthly from April to October and/or removing individual plants with a weed wrench or mattock. Mow and/or selectively smother areas of mugwort. The continuous cutting will deplete the plant's resources over time.

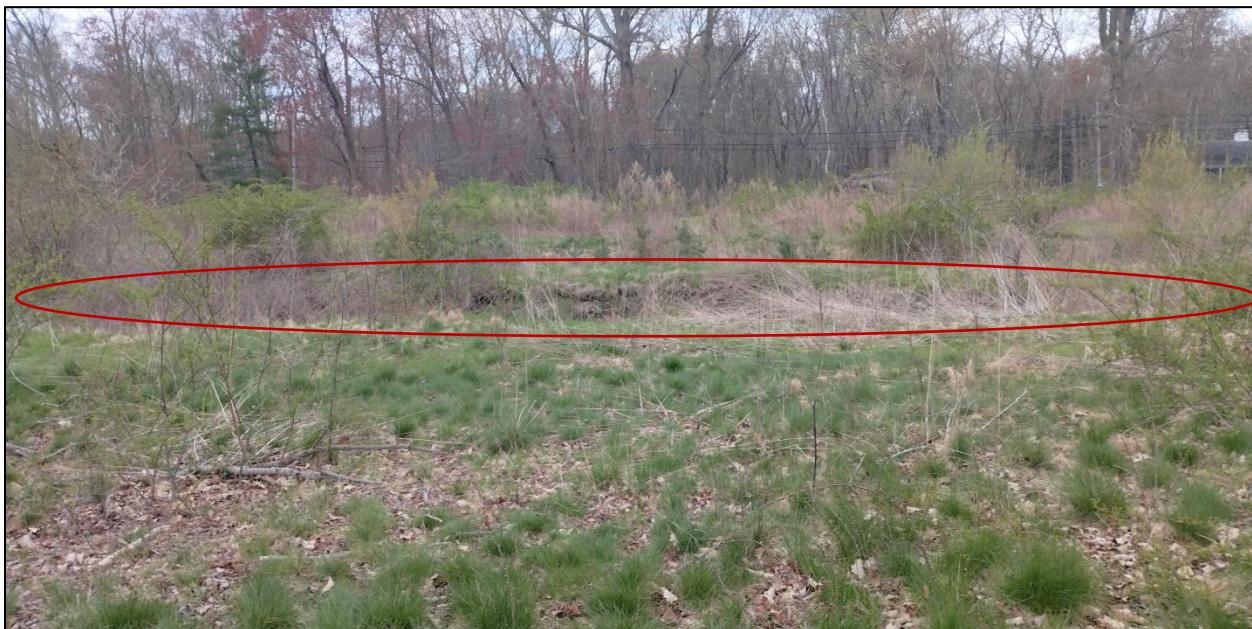
Photo 12. *Riparian Restoration.* Looking westward from the western trail segment (taken from same location as Photo 11). Note small stream lacking riparian buffer (circled in red) and invasive plant pressure.

Restore Riparian Buffer – From the edge of the streambanks to 50 feet out, we recommend using hand loppers to cut multiflora rose to just above ground level, to avoid disturbing wetland and watercourse soils. Any work in this area will require a plan to be reviewed by [Woodbridge's IWWC](#) prior to any invasive species removal. Invasive removal will help restore and enhance the habitat adjacent to the small stream on site and prevent the spread of the invasives along the watercourse.

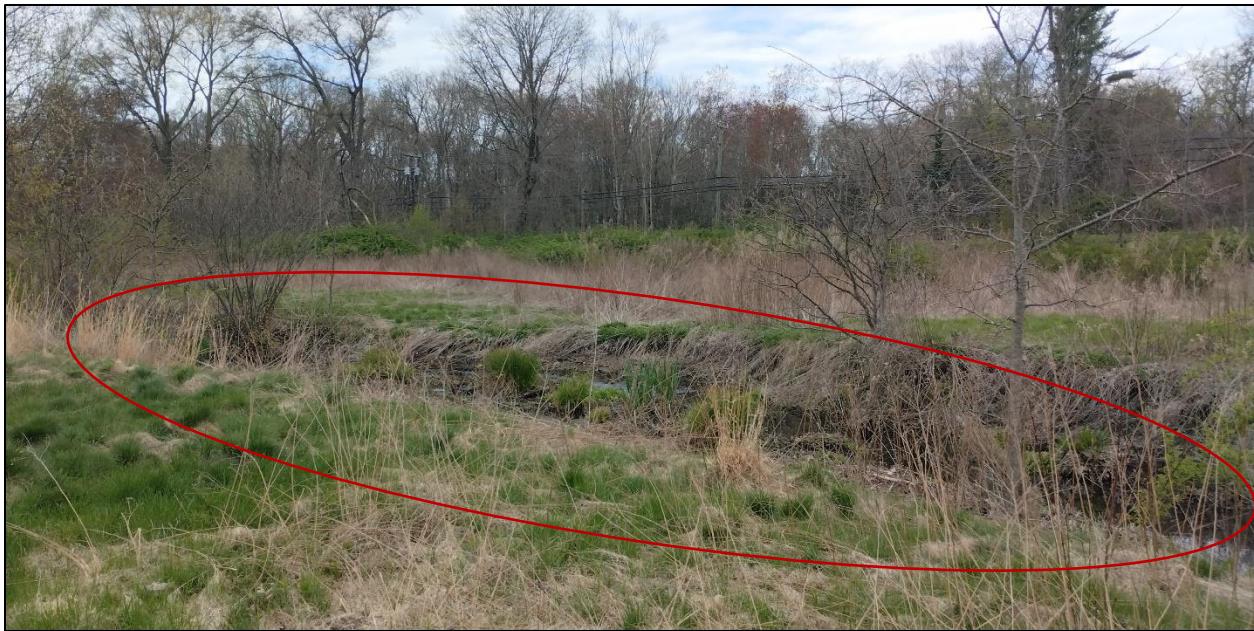
Photo 13. Riparian Restoration. West side of the western trail segment. Small stream lacks riparian buffer (circled in red) and showed evidence of erosion.

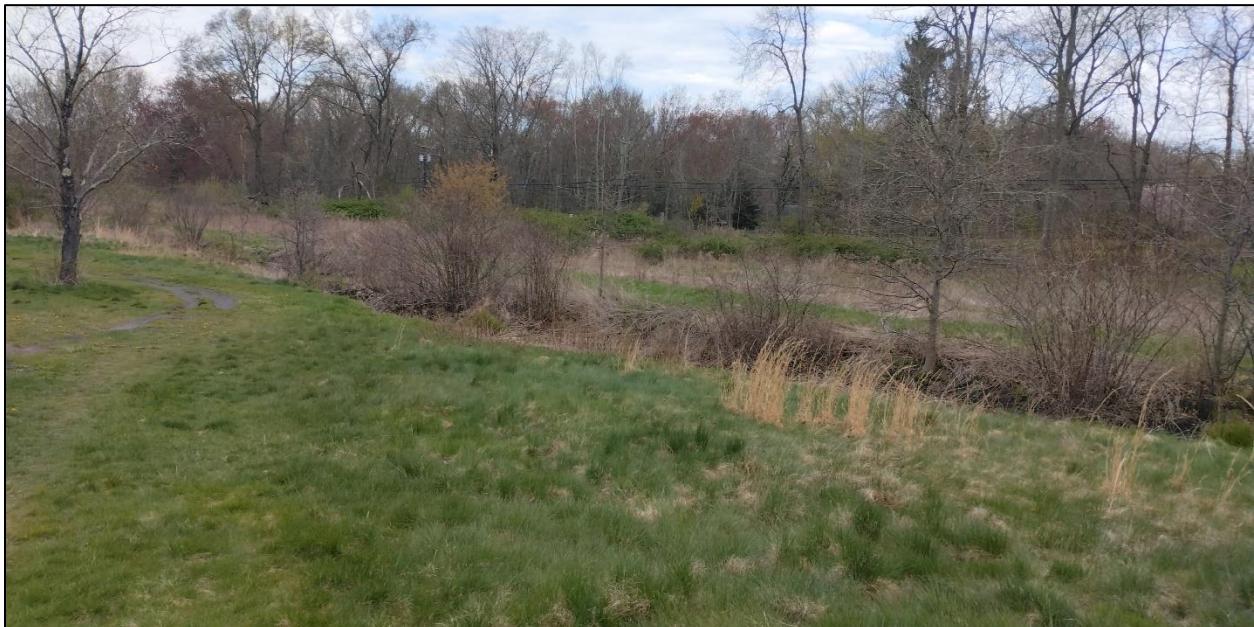
Photo 14. Riparian Restoration. Looking southwesterly towards west side of the western trail segment. Small stream has more riparian buffer in this section and note evidence of little bluestem.

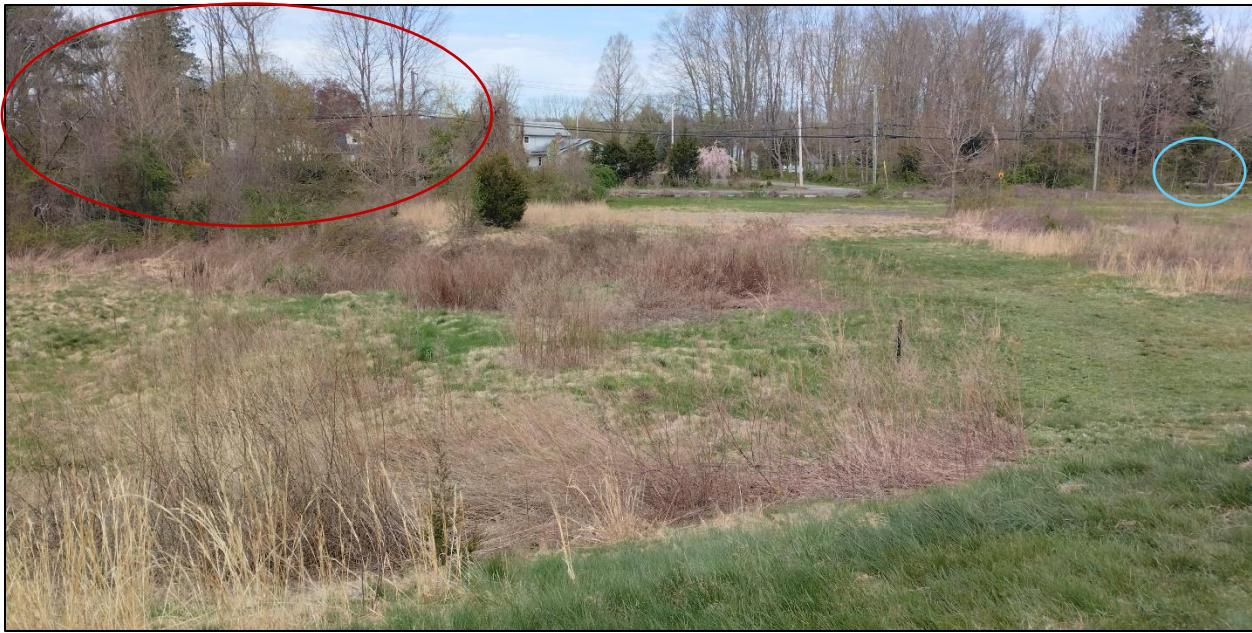
Photo 15. *Riparian Restoration – meadow enhancement.* Looking towards northwest corner of property from western trail segment. Existing gate to road in background (circled in blue). The small stream is within the wooded area in this section (circled in red).

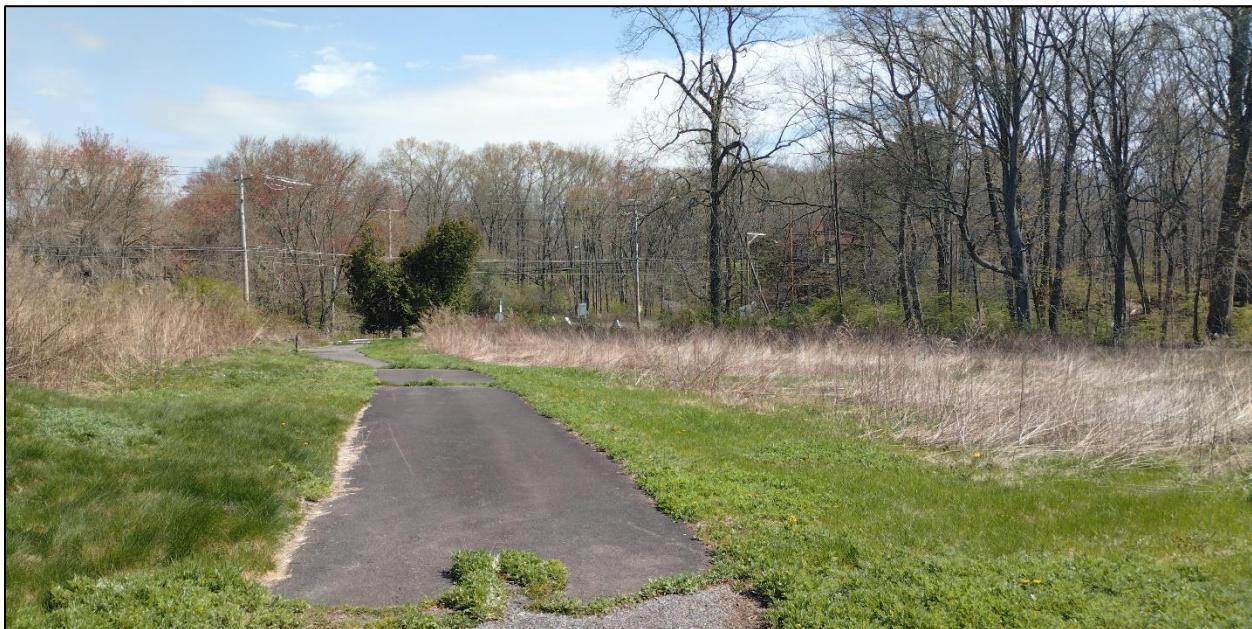
Photo 16. *Pond Restoration.* Walking easterly on northern trail segment towards northeast corner of property. The existing trail comes close to the road.

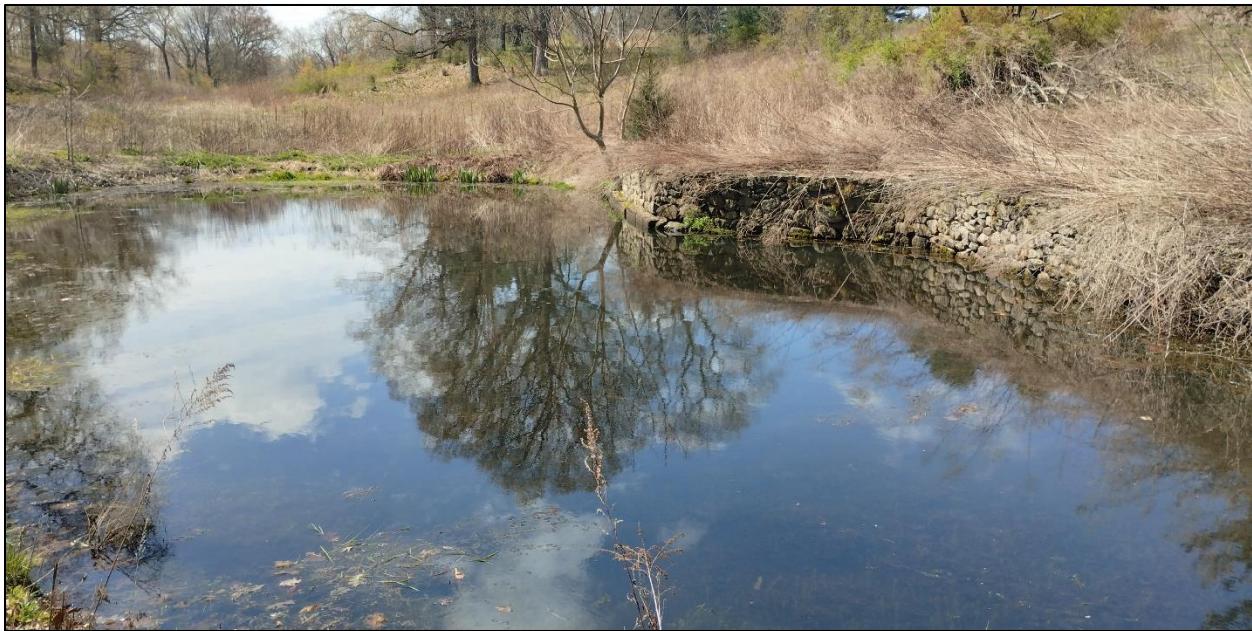
Photo 17. *Pond Restoration.* Looking southerly on the eastern trail segment. Small manmade pond offers aesthetics & habitat. Some invasive plant pressure.
